**ST. PAUL'S UNITED
METHODIST CHURCH**
CAPITAL CAMPAIGN – PHASE I

PHASE I: Fall, 2015

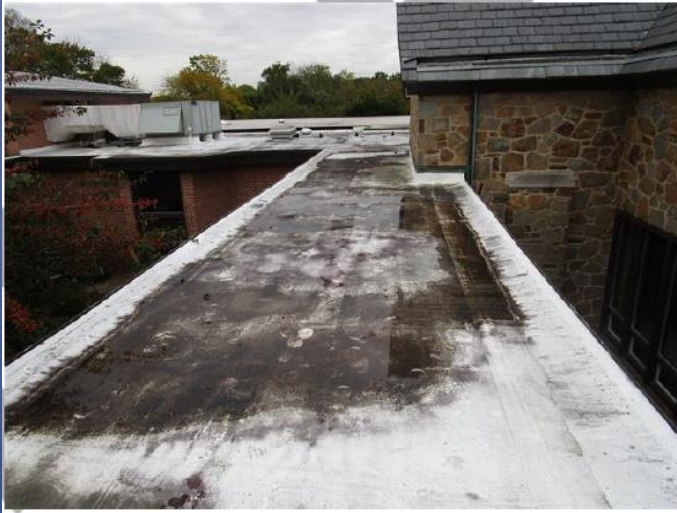
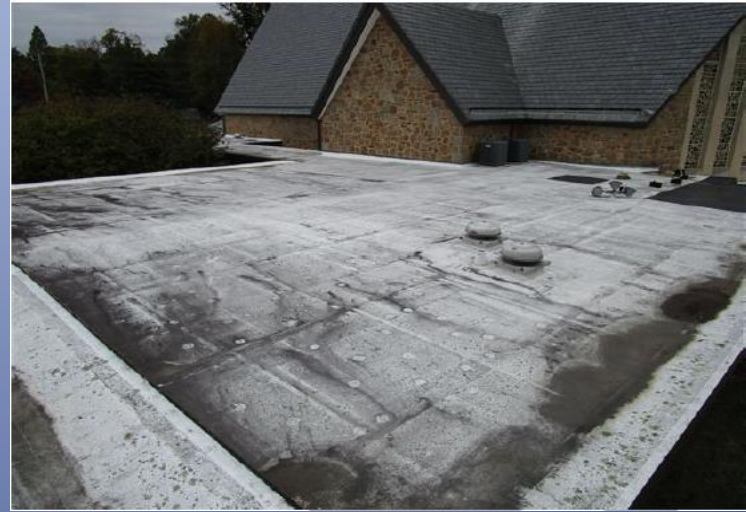
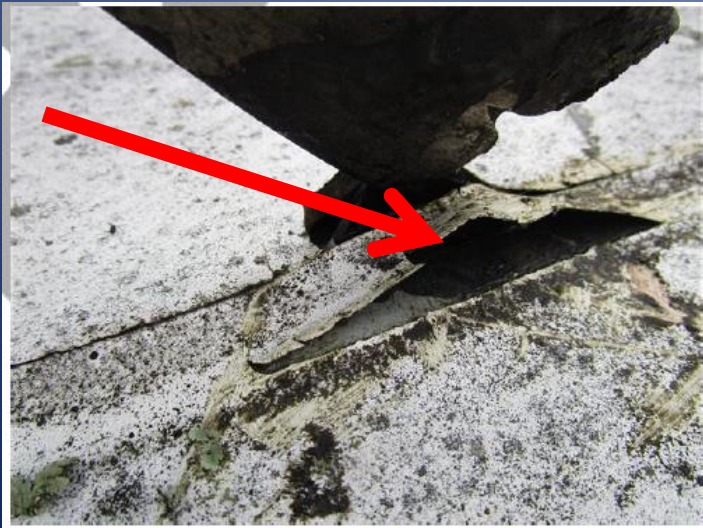
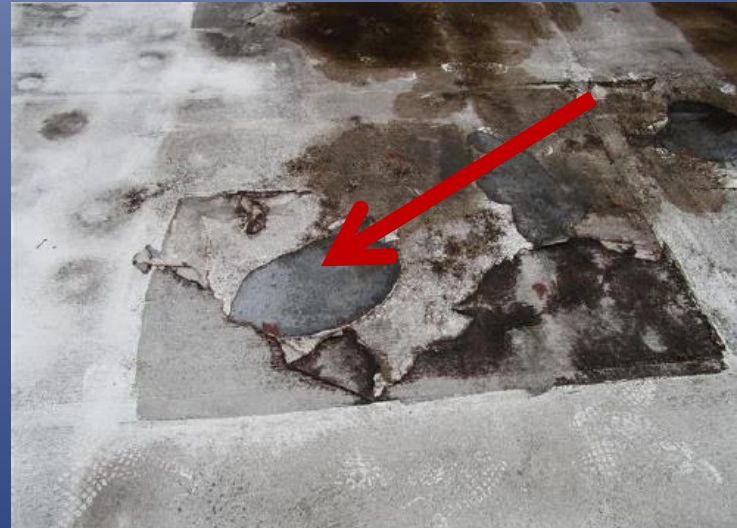
ROOF ISSUES

- 1. Coating is peeling and is too old to be repaired – it must be replaced due to contamination beneath
- 2. ALL seams are OPEN, allowing water to enter and form mold, rot, and deterioration of insulation
- 3. Leaks to the interior are damaging the structural integrity of the building

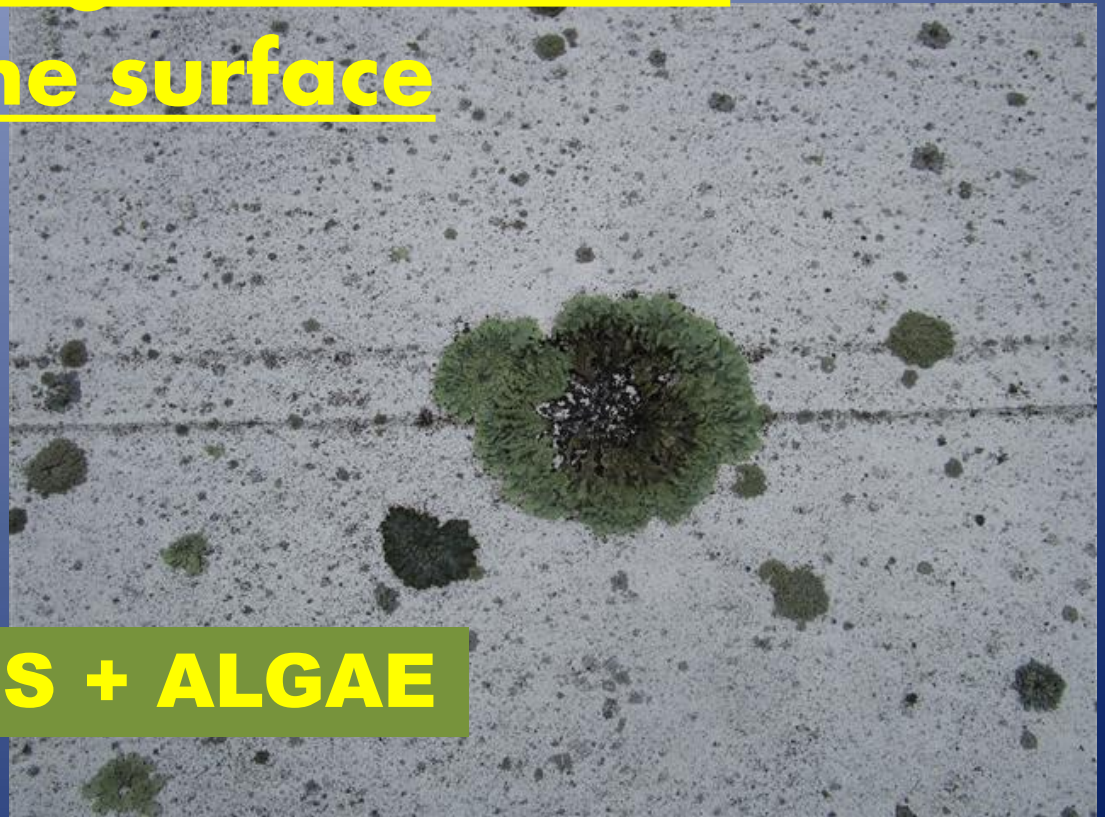
Excessive growth of molds and
vegetation throughout the roof,
on and under the surface

LICHENS: FUNGUS + ALGAE

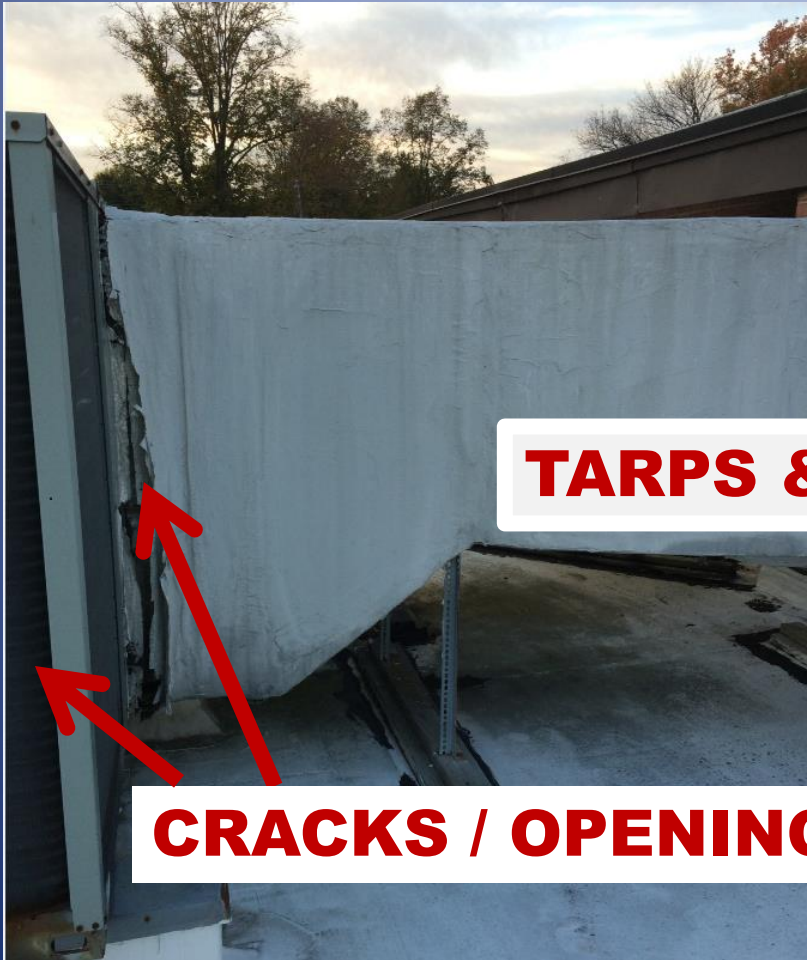
ROOF TOP HVAC SYSTEM

CRACKS / OPENINGS

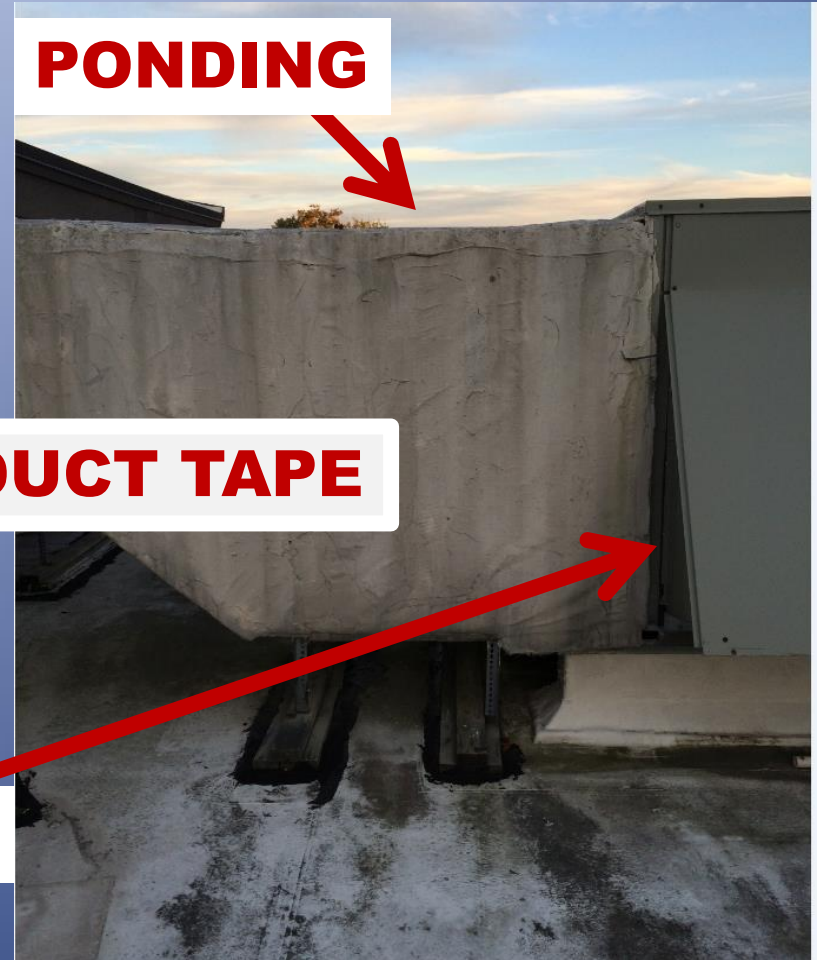
PONDING

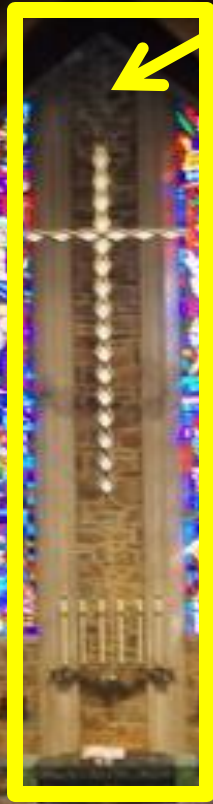
CAP

MASONRY

CHIMNEY

MORTAR

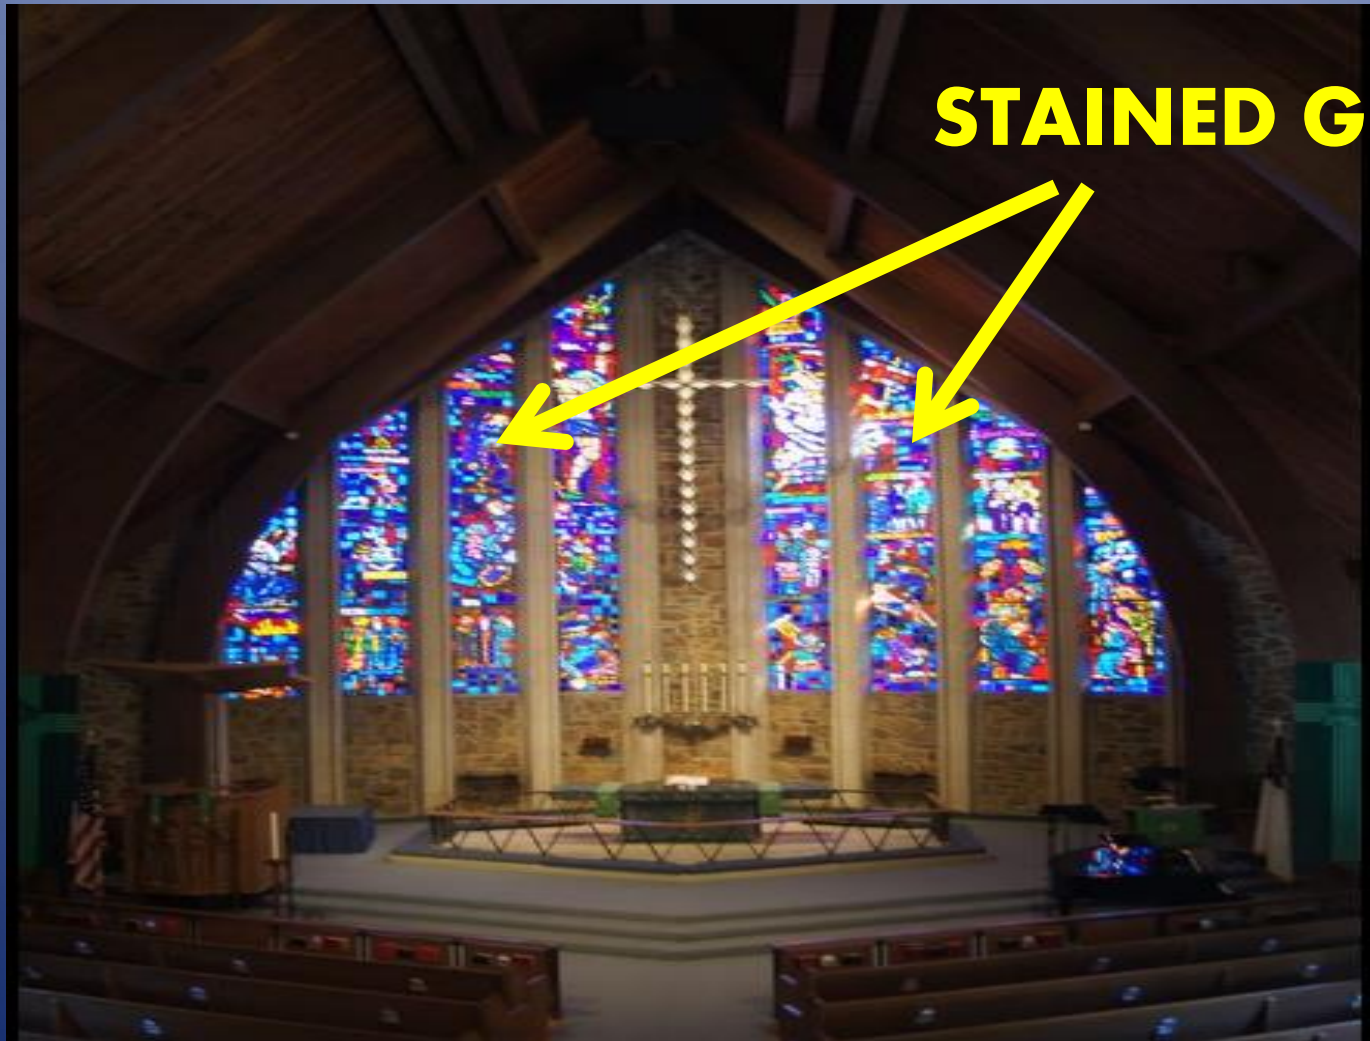
STAINED GLASS: IMMEDIATE CONCERN

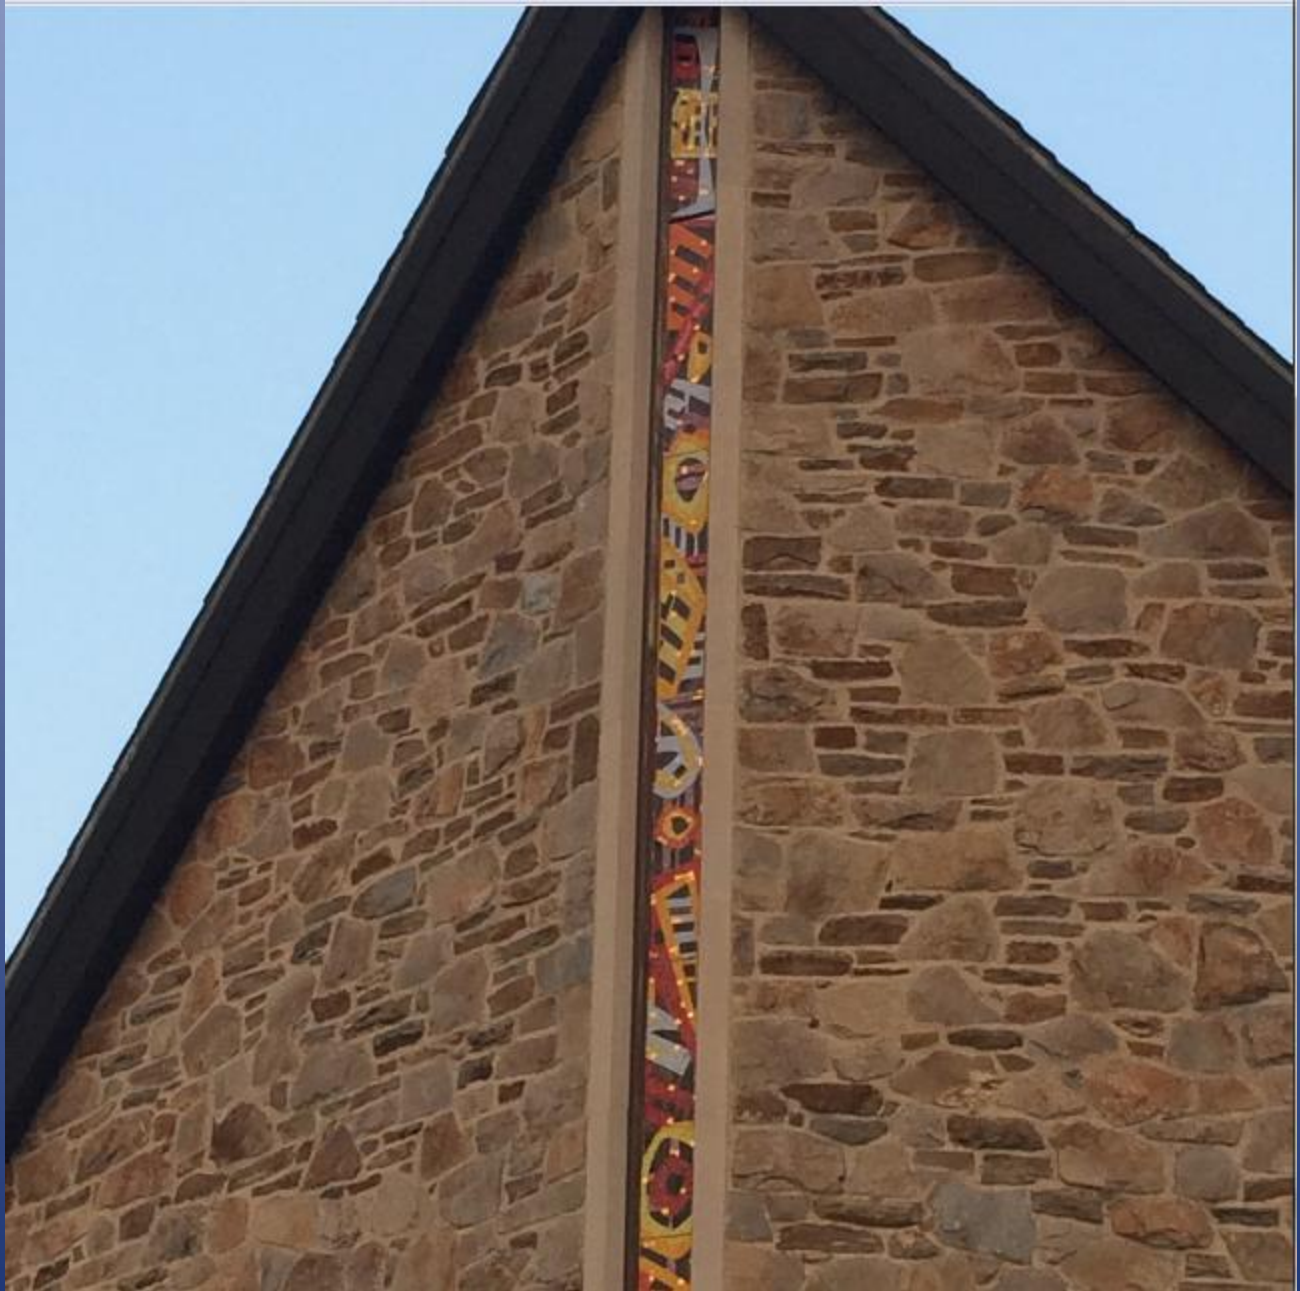
STAINED GLASS

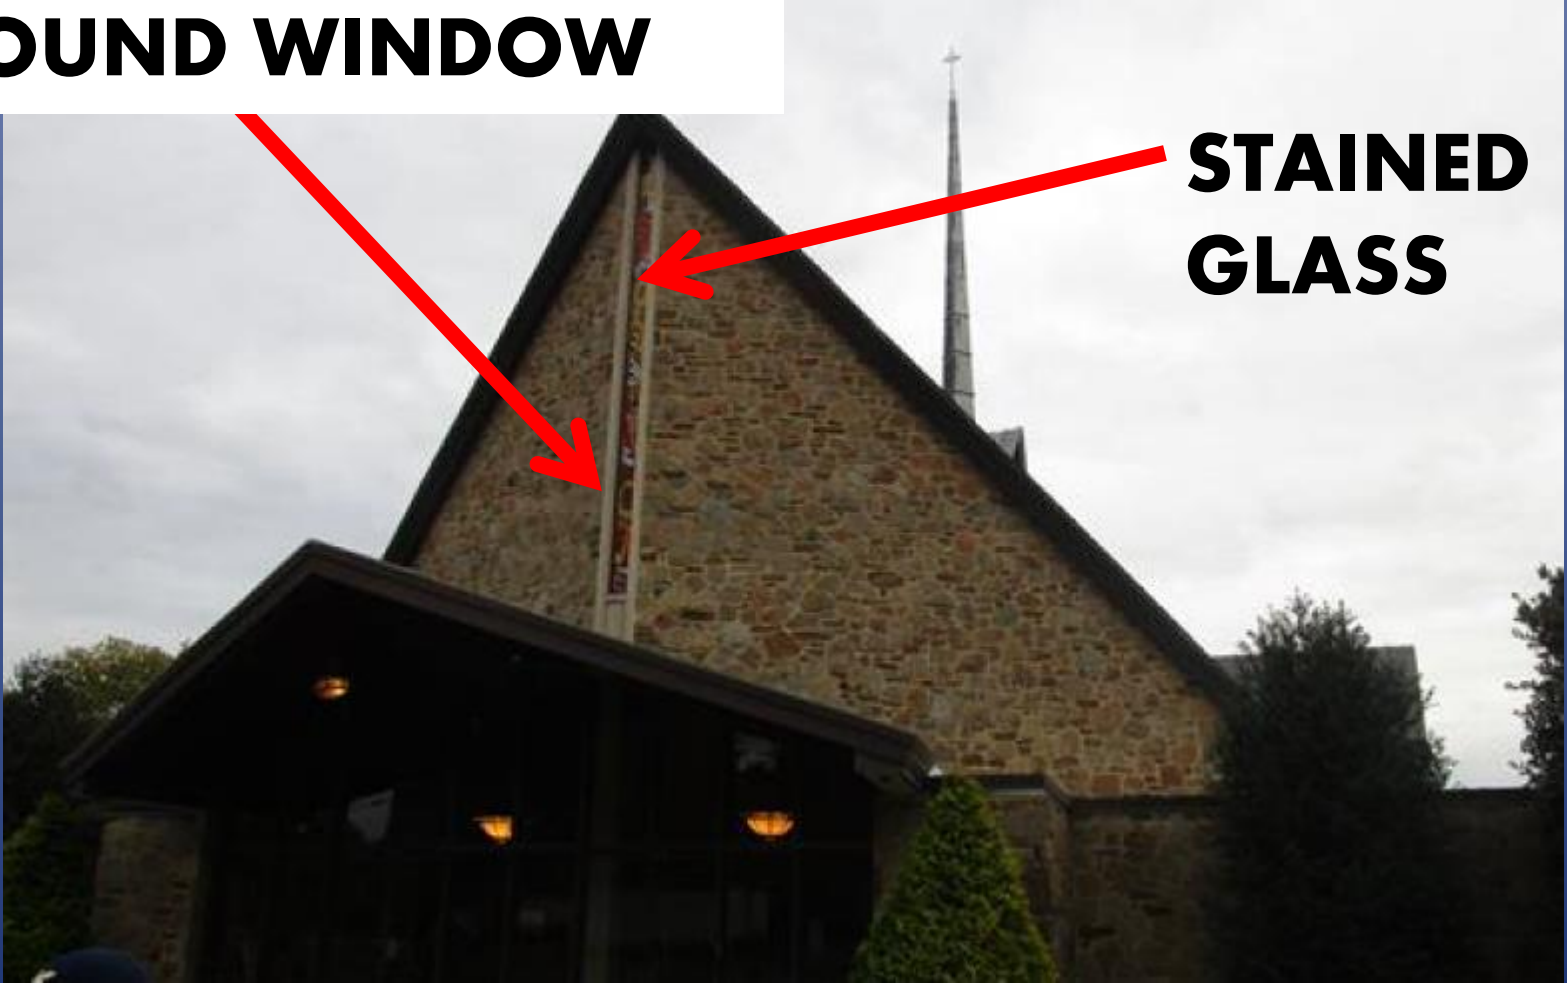
**WOOD REPLACEMENT
AROUND WINDOW**

**STAINED
GLASS**
